**Flood Control Project Maintenance  
Levee Inspections**

## Maintenance Issue Types Only, Levee Inspection Report By Mile - Fall 2016

### Reclamation District No. 2096 Wetherbee Lake

Waterway	Bank	Unit Miles	Inspection Start/End	Inspector
Unit No. 01 San Joaquin River	Right	0.16	11/02/2016 11/02/2016	Maksim Khashchuk

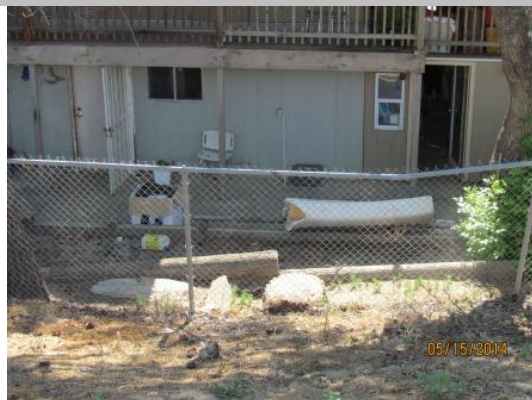
LM Start	0.06	Rating **	N	Issue No.	9					
LM End	0.06	Issue Type +	Ma	Location *	LS					
Category	Earthen Levee			GPS Latitude/Longitude						
				Start	End					
Item	Trim / Thin Trees			37.773348 °	37.773348 °					
				-121.298475 °	-121.298475 °					
DWR ID	DWR_RD2096_01_s_2014_9									
Comment Code										
T5 : Tree stumps.										
Inspector Comment										
Pine tree stump at levee toe.

View of the tree stump at the landside levee toe.

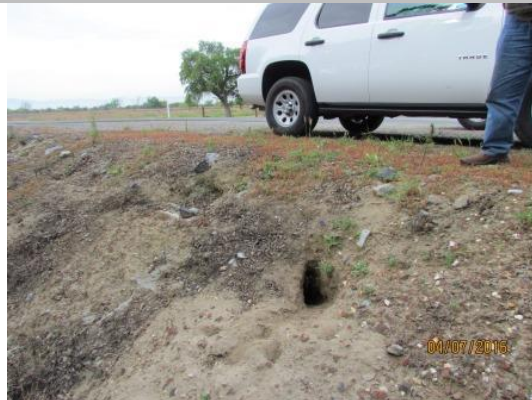
LM Start	<b>0.09</b>	Rating **	A/W	Issue No.	<b>6</b>					
LM End	<b>0.09</b>	Issue Type +	Ma	Location *	LS					
Category	Earthen Levee			GPS Latitude/Longitude						
				Start	End					
Item	Animal Control			37.772891 °	37.772891 °					
				-121.298454 °	-121.298454 °					
DWR ID	DWR_RD2096_01_s _ 2016_6									
Comment Code										
A3 : No rodents visible, but rodent burrows visible; need to backfill and compact or grout burrows.										
Inspector Comment										
LMA has effective rodent control program. Monitor this location for possible future activity.

View of the rodent hole on the landside levee slope.

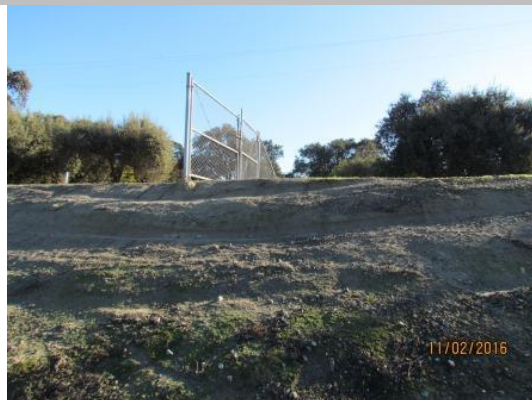
Photo 1 of 3 : FA\_2016\_RD2096\_117\_11\_20161104\_00010.jpg

LM Start	0.12	Rating **	M	Issue No.	11
LM End	0.12	Issue Type +	Ma	Location *	WS
Category	Earthen Levee			GPS Latitude/Longitude	
				Start	End
Item	Slope Stability			37.772434 °	37.772434 °
				-121.298433 °	-121.298433 °
DWR ID	DWR_RD2096_01_s_2015_11				
Comment Code					
S3 : Repair the levee slope damaged by vehicle traffic and prevent access where possible.					
Inspector Comment					
Regrade and re-compact damaged waterside levee slope.

View of the waterside slope damaged by vehicle.

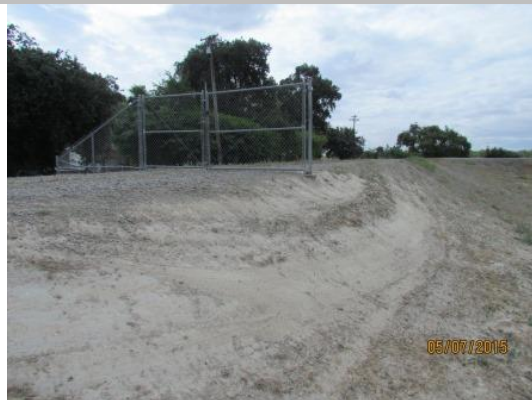
Photo 2 of 3 : FA\_2016\_RD2096\_117\_11\_20160914\_00005.jpg

View of the vehicle tracks eroding the waterside levee slope.

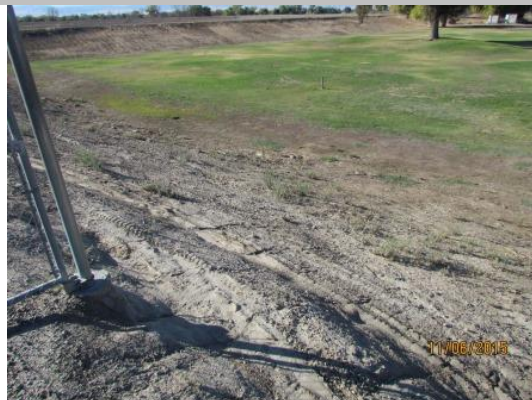
Photo 3 of 3 : FA\_2016\_RD2096\_117\_11\_20160914\_00006.jpg

Another view of the vehicle tracks on the waterside levee slope.
